BLUE COAST
ENGINEERING

Rich Passage Long-Term Beach Monitoring: May to October 2022 Beach Response Report

Kitsap Transit
60 Washington Avenue, Suite 200
Bremerton, WA 98337

February 15, 2023

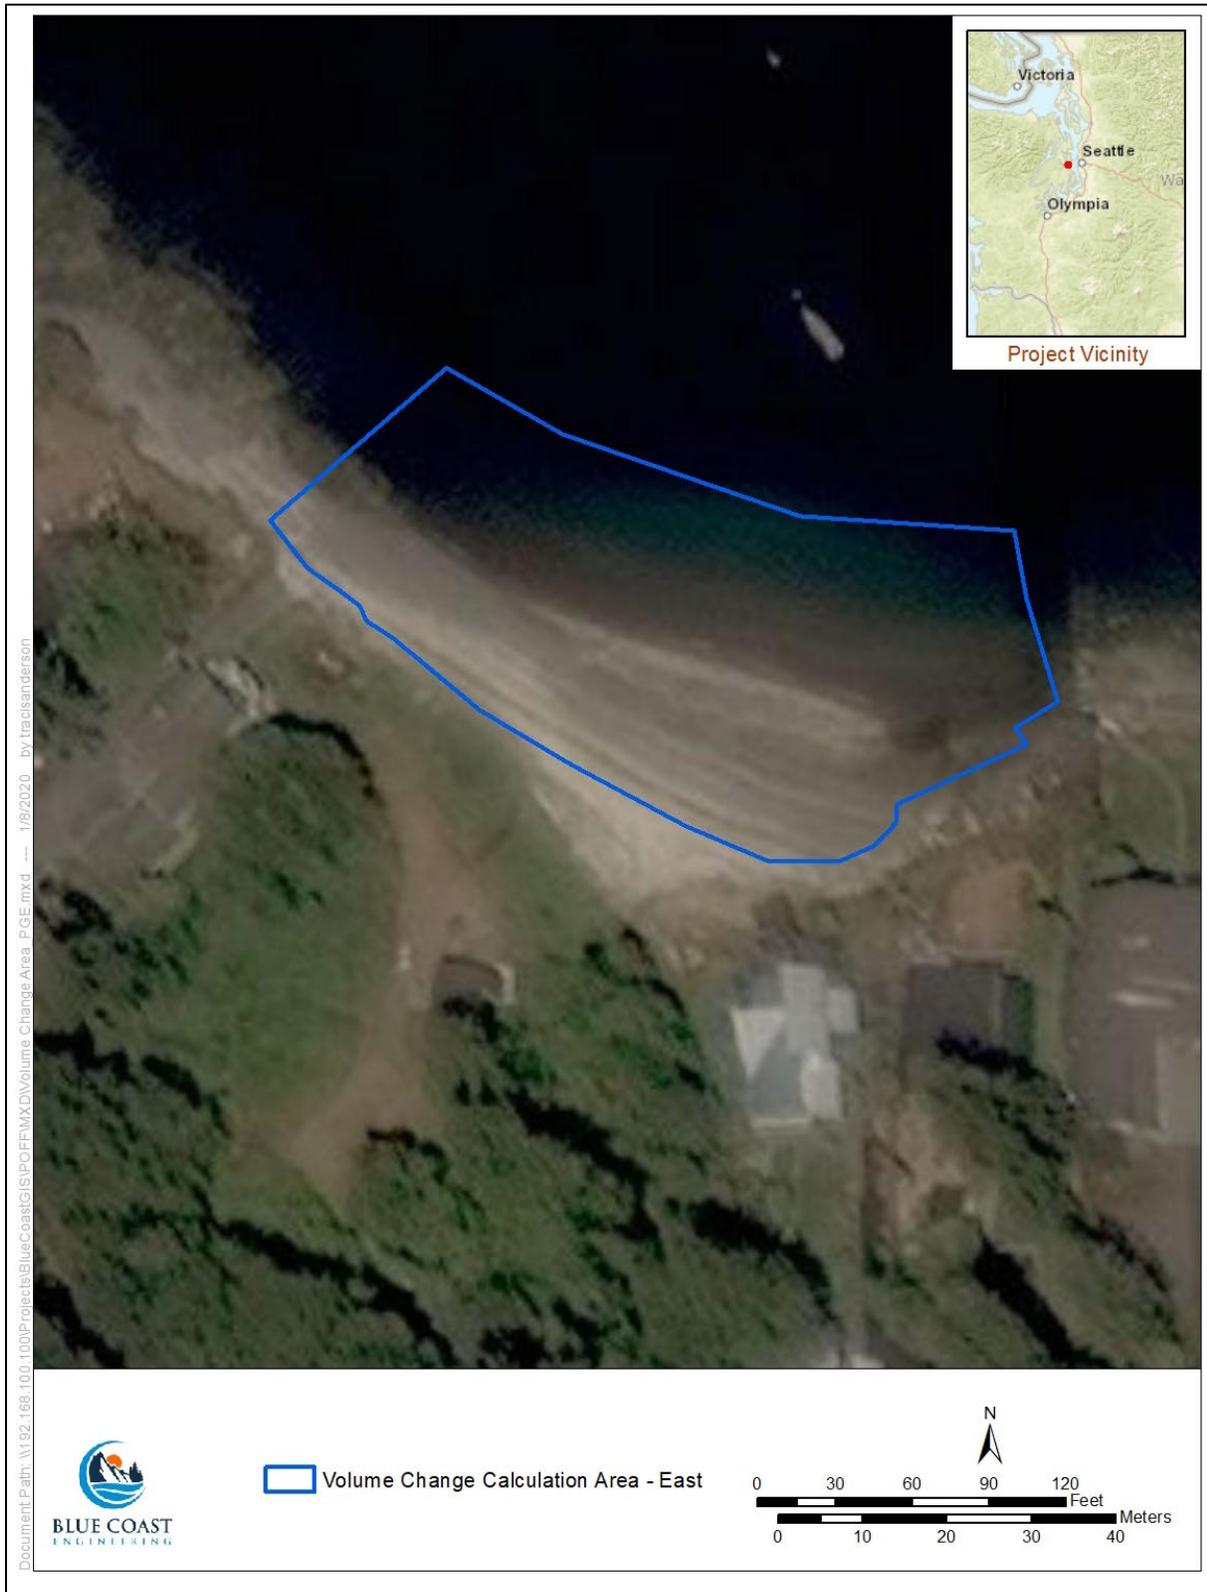
Figure 13. Area of Point Glover east where volume changes were calculated.

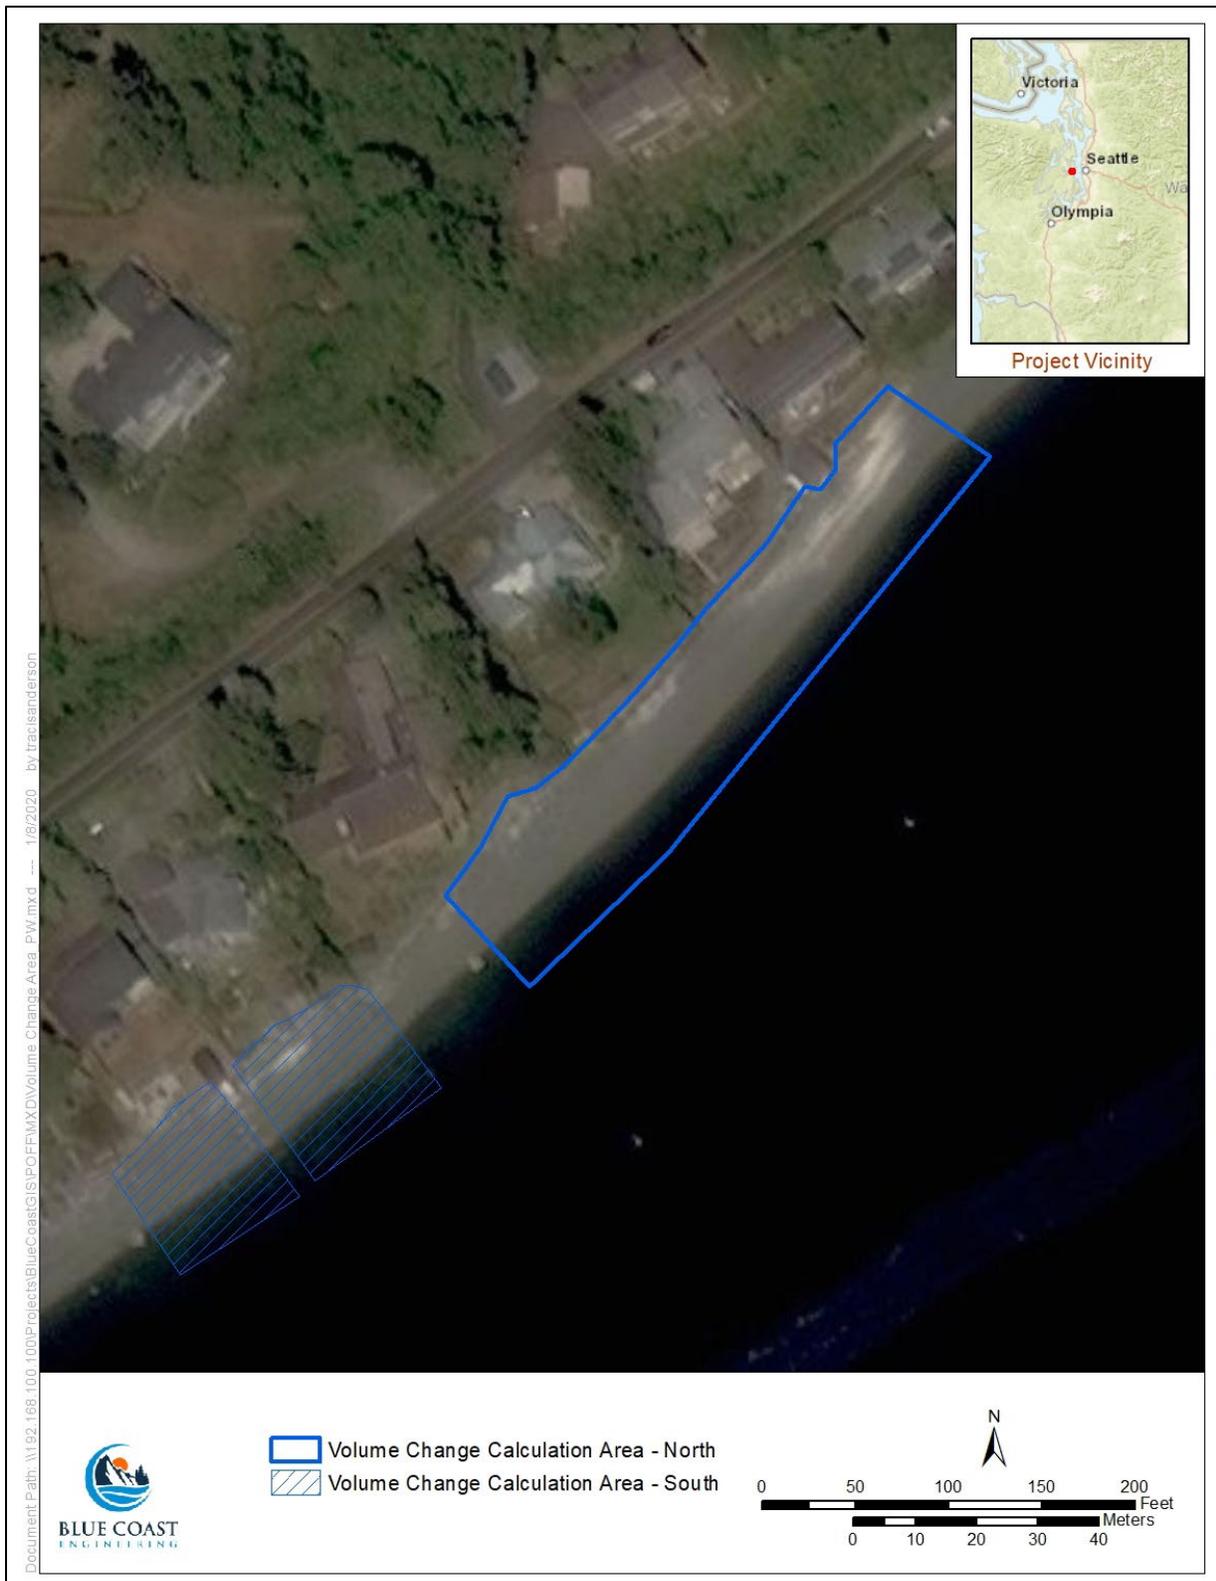
The magnitude and spatial extent of the erosion and accretion patterns along Point White vary from year to year and there is not a readily observable pattern, so further analysis was conducted to calculate the total volumetric change within two subsets of the survey area (Point White North and Point White South [Figure 21]). The results of this analysis are shown in Figure 20, where a positive number indicates a net increase in volume within the calculation area and a negative number indicates net decrease in volume.

Figure 21. Calculation area for volume changes at Point White.
